# ASBESTOS INVENTORY

☒ TRANSFORMATION

Address of the inventoried site: ACP House, Avenue Georges Henri 451, 1200 Brussels

Inventory Reference : VD 131010 WAS1756B

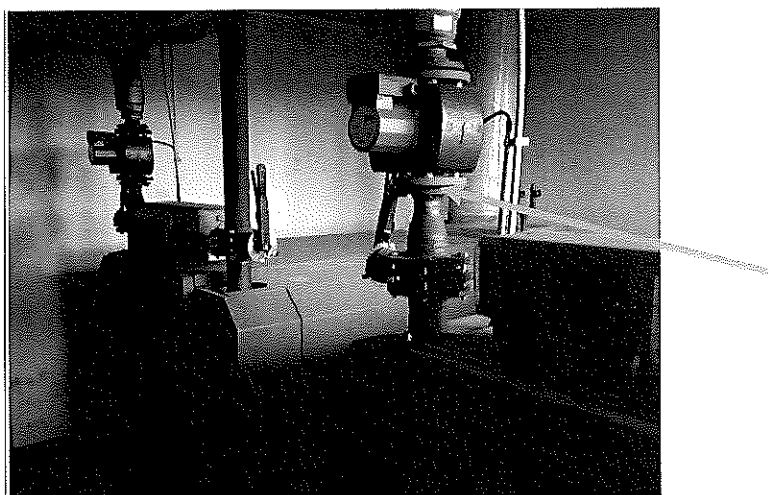
Picture 4993

Specifications	
Application and any samples ID	Application WAS1756B - 01 No sample
Type of material	Fibrous seal
Exact location of the suspect material	Level 4 - Boiler room
Amount and location of sampling in material	n/a
Approximative quantities of concerned suspect material	Some pieces
Accessibility to suspect material	Non accessible
Surface treatment	None
State of degradation, damage and scope	Unknown
Remarks	None
Conclusion	
Asbestos presence	Suspicion : Asbestos containing Klingenite

For flange seals (applications #01 & #16), suspicion is issued. Indeed, according to the time, it is possible that klingerite is asbestos containing. It is therefore advisable, when a seal is replaced or a facility is dismantled, to carry out the reject of old seals following asbestos waste regulations and maintain a register of seals. Ditto for the fuses (application # 11).

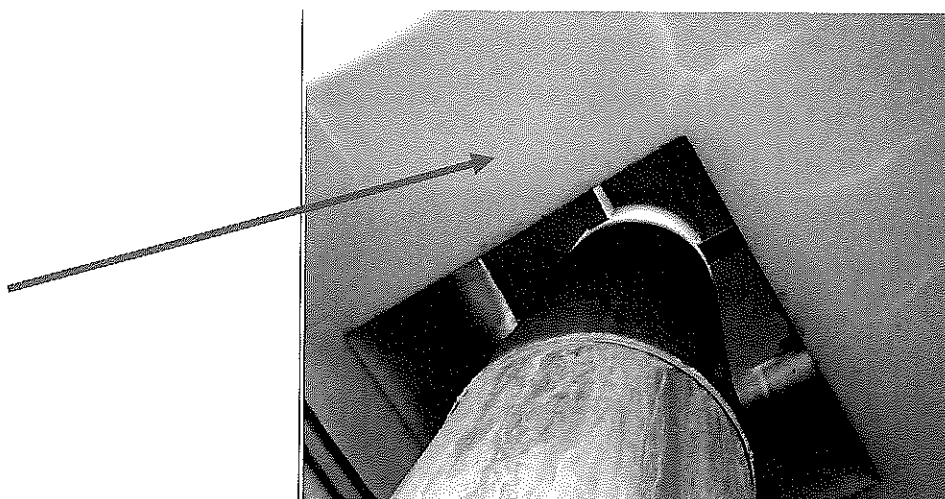
Picture 4996

Specifications	
Application and any samples ID	Application WAS1756B - 02 Sample 131010VD01
Type of material	Plaster
Exact location of the suspect material	Level 4 - Boiler room
Amount and location of sampling in material	1 sample on Boiler room wall
Approximative quantities of concerned suspect material	n/a
Accessibility to suspect material	Accessible
Surface treatment	None
State of degradation, damage and scope	Partially cracked
Remarks	None
Conclusion	
Asbestos presence	No asbestos

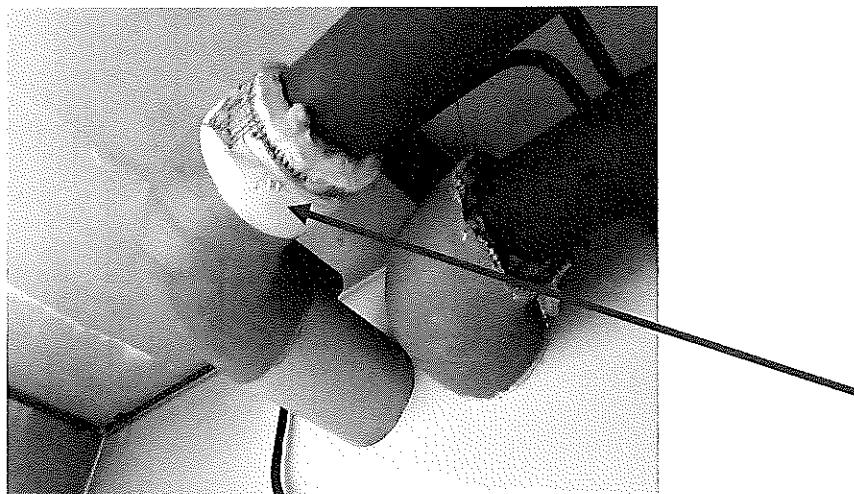
Picture 5081

Specifications	
Application and any samples ID	Application WAS1756B - 03 Sample 131010VD10
Type of material	Fibro-plaster
Exact location of the suspect material	+4 - Boiler room, stright part of pipe protected by fibro-plaster insulation
Amount and location of sampling in material	1 sample on insulation
Approximative quantities of concerned suspect material	± 0,3 m
Accessibility to suspect material	Accessible
Surface treatment	None
State of degradation, damage and scope	Partially degraded
Remarks	At the end of the Boiler Room, the pipes are not insulated by fiber-plaster but mineral wool with PVC shells
Conclusion	
Asbestos presence	<b>Positive : Amosite</b>

The building has asbestos applications as a piece of fibro-plaster pipe insulating, a fibrous plate on the door to technical hopper and joints between frames and brickwork. Their removal is to be performed by a licensed asbestos removal company. For insulation, intervention in a big single confined area is not necessary given the amount, the solution of the sleeve is recommended. To the door plate and frame seal, the "simple" removal is recommended, but in the case of frames, the difficulty is the access. The work could be postponed until the replacement of the frames.

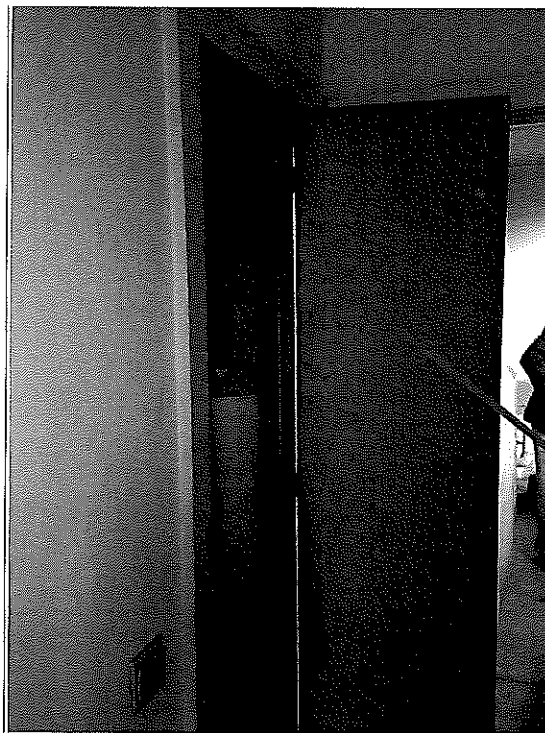
Picture 4999

Specifications	
Application and any samples ID	Application WAS1756B - 04 Sample 131010VD02
Type of material	Fibrous pannel
Exact location of the suspect material	+4 - corridor to Boiler room, interior of door giving access to technical hopper connecting all floors.
Amount and location of sampling in material	1 sample on pannel
Approximative quantities of concerned suspect material	$\pm 1,2 \text{ m}^2$
Accessibility to suspect material	Accessible
Surface treatment	None
State of degradation, damage and scope	Good state
Remarks	None
Conclusion	
Asbestos presence	<b>Positive : Chrysotile and amosite</b>

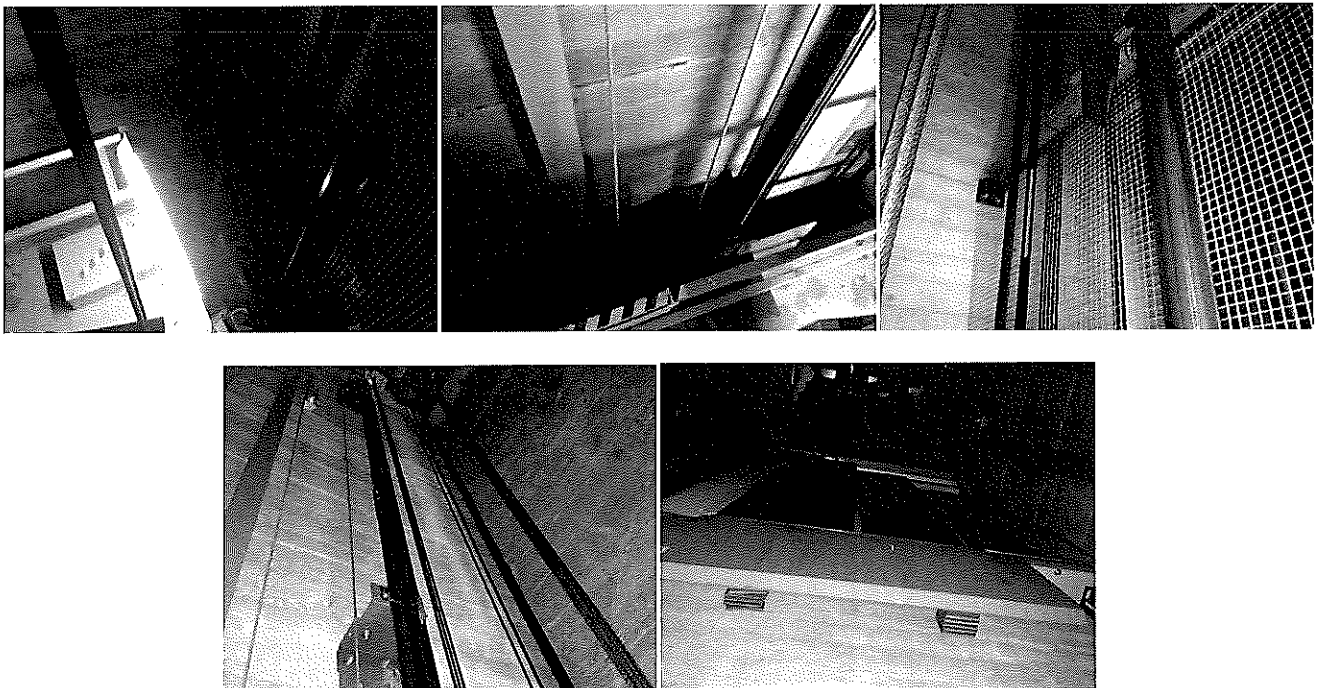
Pictures 5082 to 5086 : Lift hopper visit

Specifications	
Application and any samples ID	Application WAS1756B - 05 No sample
Type of material	Lift hopper
Exact location of the suspect material	+4 – -2
Amount and location of sampling in material	n/a
Approximative quantities of concerned suspect material	2 lifts
Accessibility to suspect material	Accessible via OTIS
Surface treatment	None
State of degradation, damage and scope	Good state
Remarks	None
Conclusion	
Asbestos presence	No A.C.M.

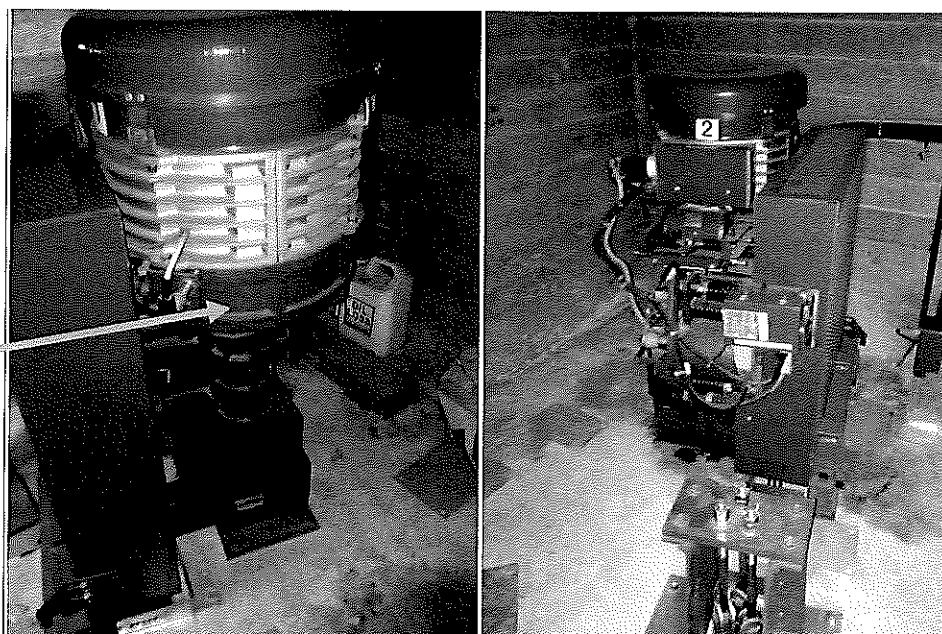
Pictures 5005 et 5006

Specifications	
Application and any samples ID	Application WAS1756B - 06 No sample
Type of material	Lifts brake pads
Exact location of the suspect material	+5 - lifts machinery
Amount and location of sampling in material	n/a
Approximative quantities of concerned suspect material	2 lifts
Accessibility to suspect material	Non accessible
Surface treatment	None
State of degradation, damage and scope	n/a : wear part
Remarks	According to the Otis technician , the probability is very low for whether it is still asbestos brake pads, but the suspicion is kept, no sample can be taken.
Conclusion	
Asbestos presence	Suspicion : asbestos containing

Regarding the brake pads of the lift machinery (application # 06), it is necessary to check with the maintenance company for lifts (sampling not possible). While the technician is unsure of the absence of asbestos, it could not produce the evidence. As a reminder, the Royal Decree of 9 March 2003, amended on March 17, 2005, as part of the risk analysis in elevators, requires that the brake pads are asbestos-free since 1 January 2013.

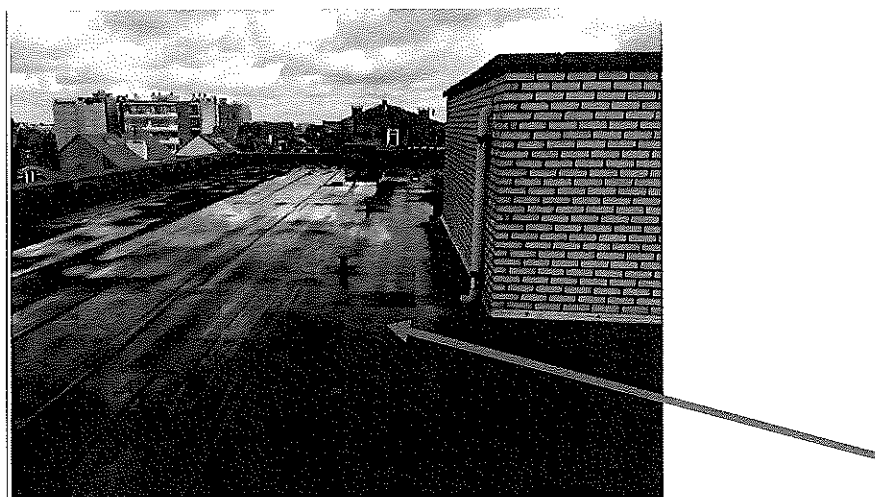
Picture 5007

Specifications	
Application and any samples ID	Application WAS1756B - 07 Sample 131010VD03
Type of material	Roofing
Exact location of the suspect material	EXT - Roof of street building
Amount and location of sampling in material	1 sample on coating
Approximative quantities of concerned suspect material	n/a
Accessibility to suspect material	Accessible
Surface treatment	None
State of degradation, damage and scope	Good state
Remarks	None
Conclusion	
Asbestos presence	No asbestos

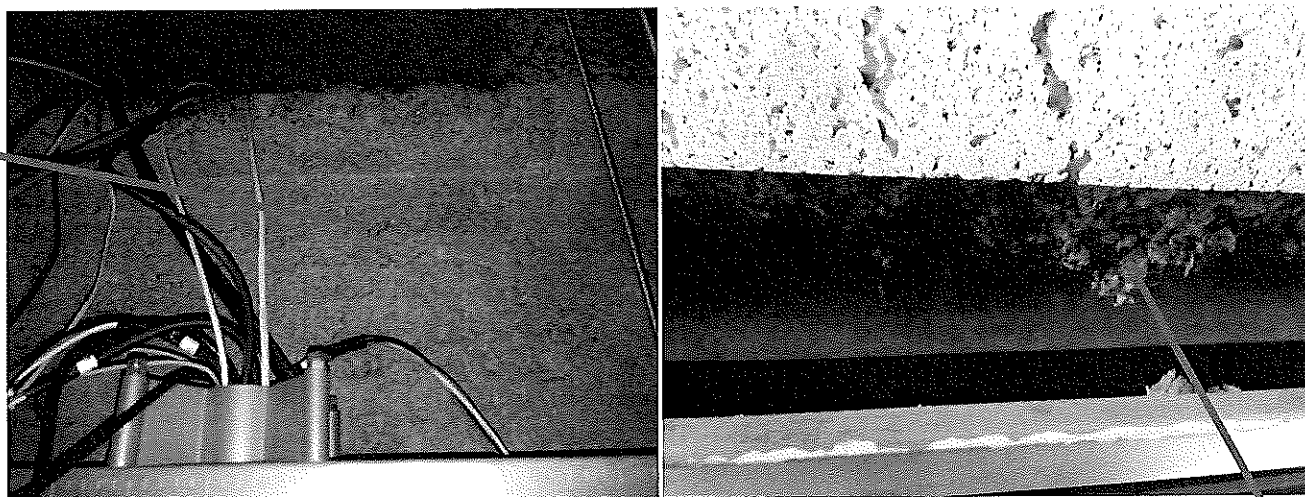
Pictures 5012 and 5015

Specifications	
Application and any samples ID	Application WAS1756B – 09 Sample 131010VD04
Type of material	Flocking insulation
Exact location of the suspect material	Rear building - +1 - Conference Room C and translation zones, around air conditioning ducts placed above the false ceiling
Amount and location of sampling in material	1 sample on insulation in Conference room C
Approximative quantities of concerned suspect material	n/a
Accessibility to suspect material	With difficulty
Surface treatment	None
State of degradation, damage and scope	Partially degraded
Remarks	None
Conclusion	
Asbestos presence	No asbestos

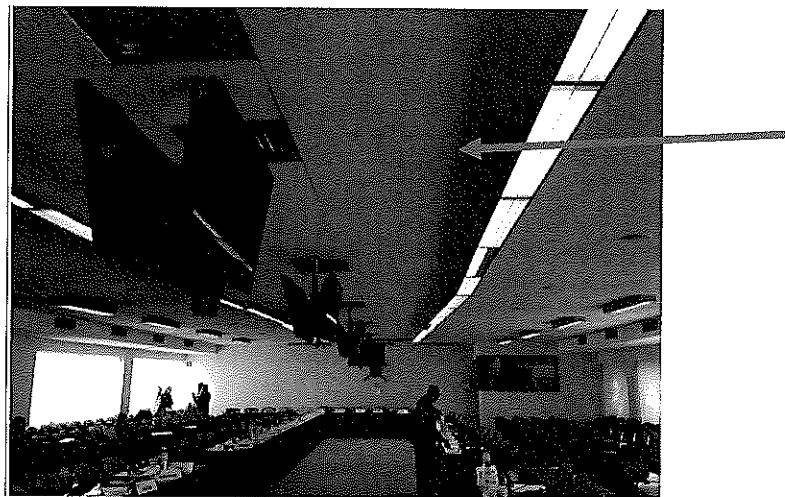
Picture 5016

Specifications	
Application and any samples ID	Application WAS1756B – 10 Sample 131010VD05
Type of material	False ceiling plates
Exact location of the suspect material	Rear building - +1 - Conference Room C and translation zones
Amount and location of sampling in material	1 sample on false ceiling plate in conference room C
Approximative quantities of concerned suspect material	n/a
Accessibility to suspect material	Accessible
Surface treatment	None
State of degradation, damage and scope	Good state
Remarks	None
Conclusion	
<b>Asbestos presence</b>	<b>No asbestos</b>

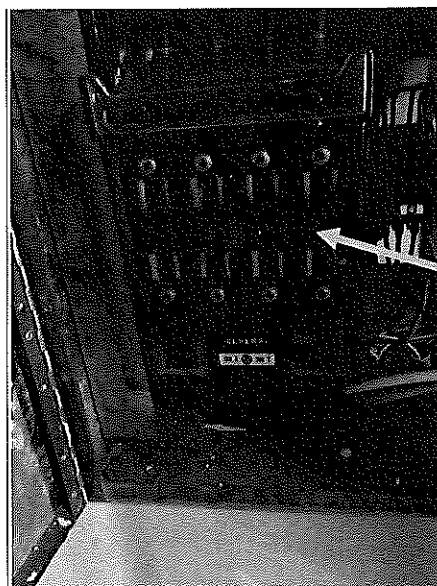
Picture 5030

Specifications	
Application and any samples ID	Application WAS1756B – 11 No sample
Type of material	Rope
Exact location of the suspect material	Rear building - +1 - Electrical cabinet in corridor translation zones - generally, any occurrence of NH industrial fuse
Amount and location of sampling in material	n/a
Approximative quantities of concerned suspect material	Some pieces
Accessibility to suspect material	Non accessible
Surface treatment	None
State of degradation, damage and scope	Unknown
Remarks	There may be a asbestos rope seal between the body and fuse covers
Conclusion	
Asbestos presence	Suspicion : asbestos rope

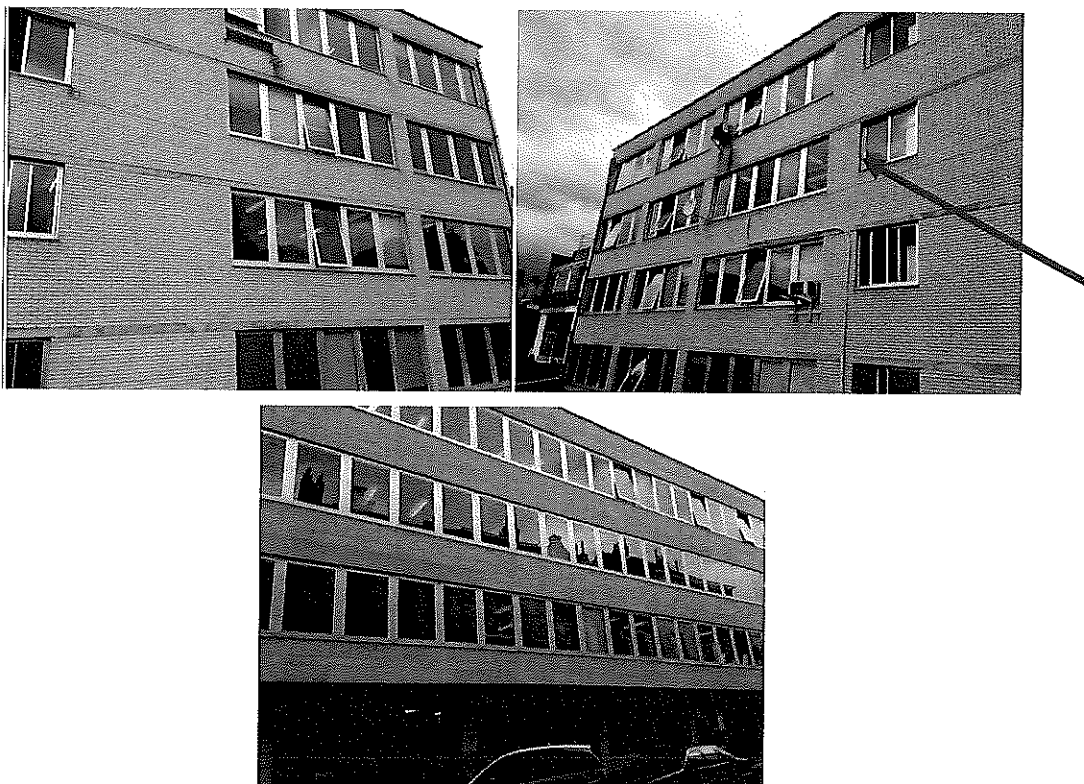
Pictures 5032, 5033 and 4992

Specifications	
Application and any samples ID	Application WAS1756B – 12 Sample 131010VD11
Type of material	External window frame seal
Exact location of the suspect material	All levels, all frames, seal between frame and brickwork
Amount and location of sampling in material	1 sample at level +2, rear facade
Approximative quantities of concerned suspect material	± 750 to 1000 m
Accessibility to suspect material	With difficulty
Surface treatment	None
State of degradation, damage and scope	Good state
Remarks	None
Conclusion	
<b>Asbestos presence</b>	<b>Positive : Chrysotile</b>

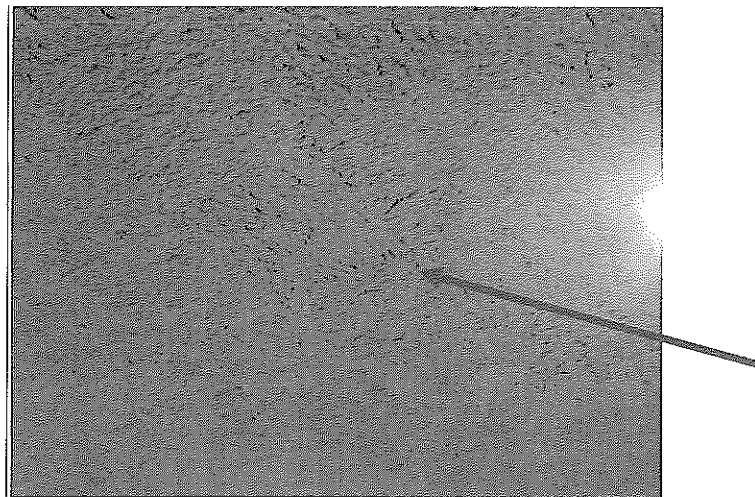
Picture 5037

Specifications	
Application and any samples ID	Application WAS1756B – 13 Sample 131010VD08
Type of material	False ceiling plates
Exact location of the suspect material	Level 0, hall conference rooms B, C and cafeteria
Amount and location of sampling in material	1 sample on false ceiling plate
Approximative quantities of concerned suspect material	n/a
Accessibility to suspect material	Accessible
Surface treatment	None
State of degradation, damage and scope	Good state
Remarks	None
Conclusion	
<b>Asbestos presence</b>	<b>No asbestos</b>

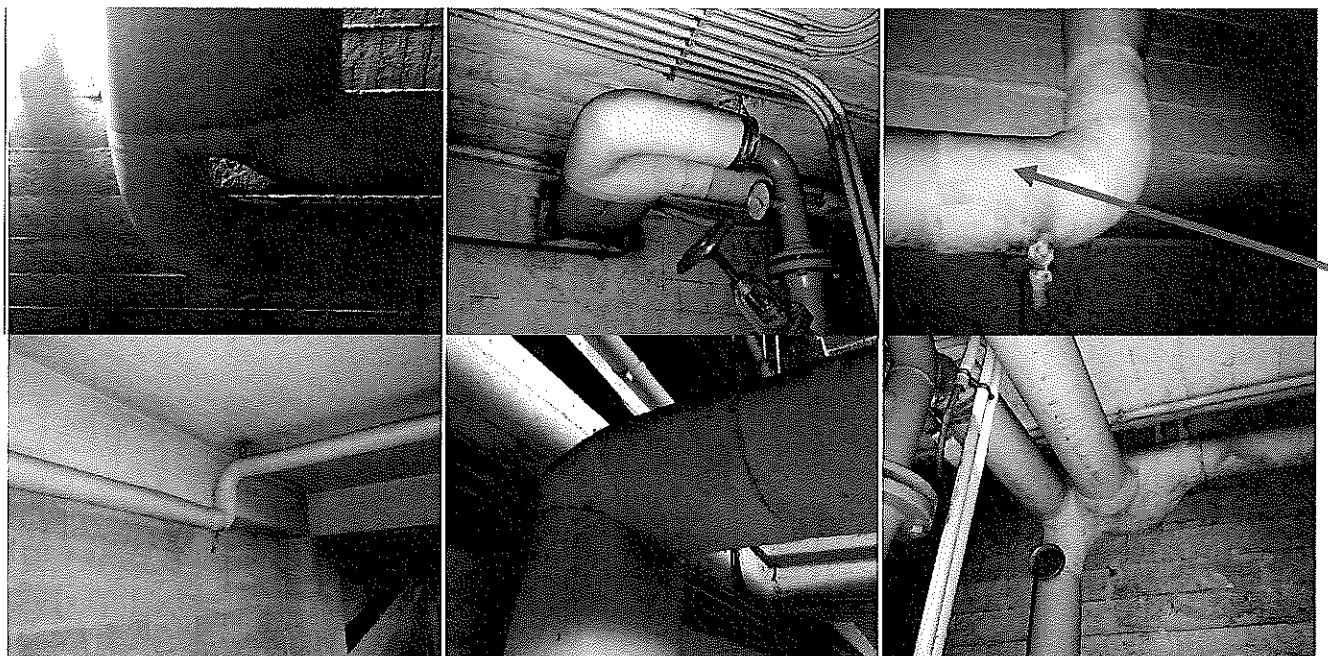
Pictures 5057, 5058, 5067, 5068, 5071, 5072

Specifications	
Application and any samples ID	Application WAS1756B – 14 Sample 131010VD09
Type of material	Fibro-plaster
Exact location of the suspect material	-1 and -2, heating pipes elbows insulation
Amount and location of sampling in material	1 sample on elbow insulation outside the lift hall -1
Approximative quantities of concerned suspect material	About 10 pieces
Accessibility to suspect material	Accessible
Surface treatment	None
State of degradation, damage and scope	Partially degraded
Remarks	Only elbows are left fibro-plaster, straight pipes are insulated with mineral wool with PVC shell
Conclusion	
<b>Asbestos presence</b>	<b>No asbestos</b>

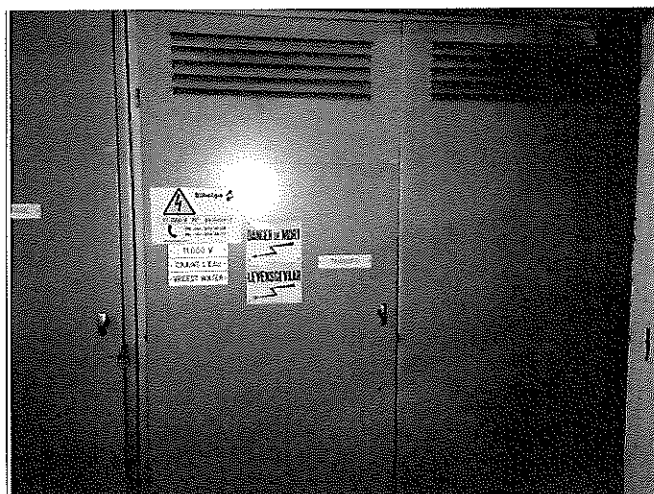
Picture 5059

Specifications	
Application and any samples ID	Application WAS1756B – 15 No sample
Type of material	Asbestos-cement
Exact location of the suspect material	-1, high voltage cabin
Amount and location of sampling in material	n/a
Approximative quantities of concerned suspect material	?
Accessibility to suspect material	No access during the visit
Surface treatment	Unknown
State of degradation, damage and scope	Unknown
Remarks	Frequent application in this type of installation
Conclusion	
Asbestos presence	Suspicion : asbestos-cement plates as insulation between HV cabin elements

Finally, an internal control of the high voltage cabin will confirm the presence of asbestos cement separation plates. It should be noted that the removal of these must be carried by a licensed asbestos removal company, and it requires a complete shut-down of the cabin.

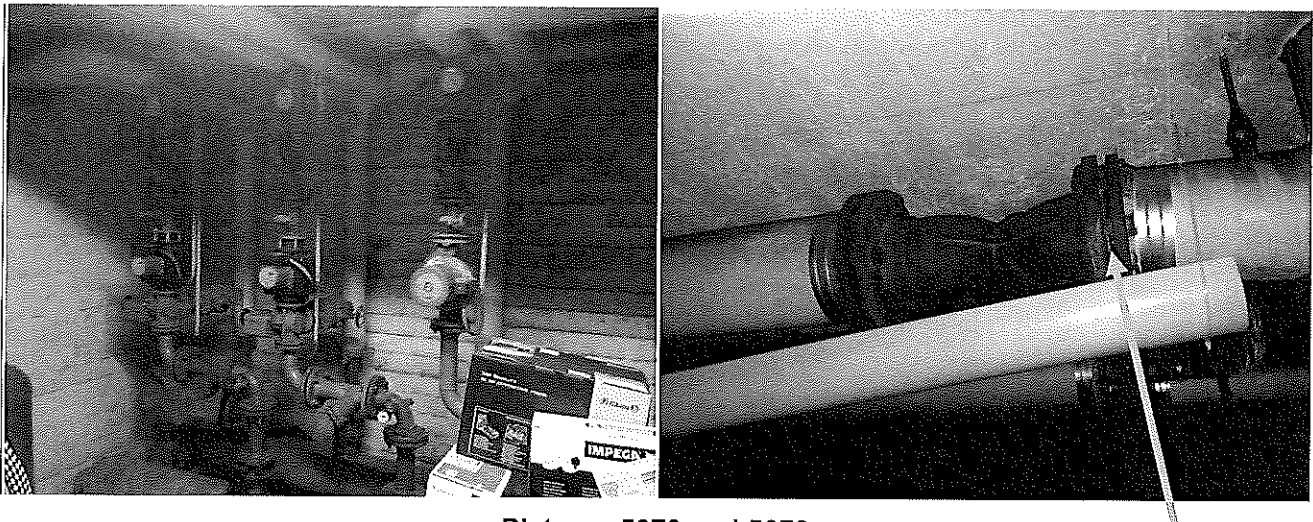
Pictures 5073 and 5079

Specifications	
Application and any samples ID	Application WAS1756B – 16 No sample
Type of material	Fibrous seal
Exact location of the suspect material	-2 circulators room
Amount and location of sampling in material	n/a
Approximative quantities of concerned suspect material	Some pieces
Accessibility to suspect material	Non accessible
Surface treatment	None
State of degradation, damage and scope	Unknown
Remarks	None
Conclusion	
<b>Asbestos presence</b>	<b>Suspicion : Asbestos containing Klingensite</b>
