TECHNICAL ASSISTANCE FOR A COMPLETE ARCHITECTURE AND ENGINEERING MISSION AND
PROJECT MANAGEMENT SERVICES FOR THE EXTENSIVE RENOVATION OF THE
AVENUE GEORGE HENRI 451 – 1200 BRUXELLES, Ref: ACP 4/1/83 (Vol. 1) 3/2016

Inception Report

Extensive Renovation of the Brussels

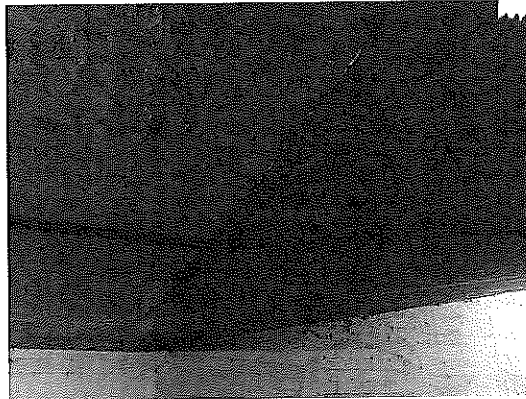
Figure 1 : Structural cracks ramp

Depending on the new layout of the conference center, it is likely that new foundations will have to be built locally and that existing foundations will have to be verified. This will involve performing soil tests with local destruction of the concrete floor of -2.

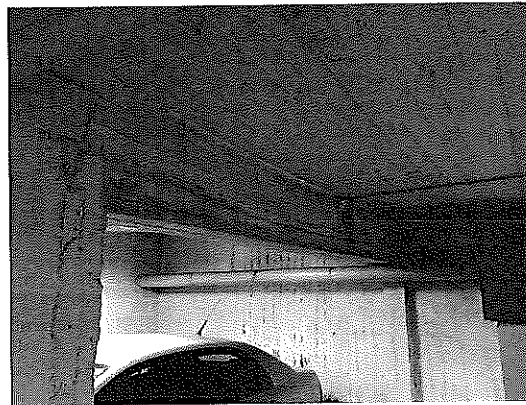
Figure 2 : Deformation of the slab

Additional investigations have been carried out in Feb. 2019 to check the void above the ceilings, we now have a clear understanding of the position of the concrete slabs. However, deeper investigation will have to be carried out at some stage of the project to identify what reinforcement exists in the concrete structure, where necessary at the request of the stability engineer in function of the planned works. These investigations will have to be organised in accordance with ACP with intervention of a contractor, they will imply production of noise and dust.

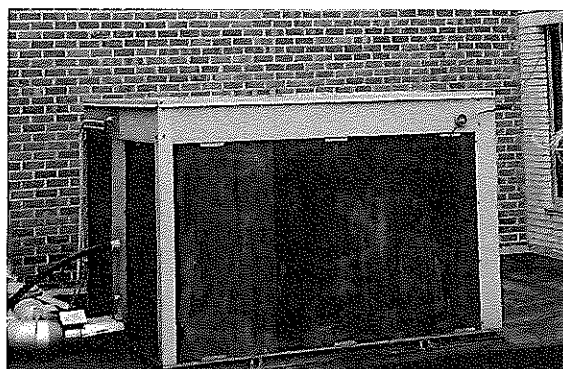
The Conference Building is refreshed by a 200 kW monobloc cooling machine, with a scroll compressor (retrofitted in 2016). As stated before, this cooling machine generates chilled water for cold batteries mounted on the supply air handling units of the building. It also provides chilled water to a set of fan coils located in the different meeting rooms.

Figure 7 : Existing cooling machine (Trane® monobloc chiller with scroll compressors)

As part of the upcoming refurbishment works, the entire air-conditioning system has to be redesigned in order to meet updated needs of both Office and Conference buildings, while minimizing investment, maintenance and exploitation costs. To achieve this, project studies will focus on:

- the selection of a powerful cooling system adapted to updated thermal gains of the building;
- the selection of suitable sizes and locations for the cooling machine(s) as well as terminal units;
- the design of a distribution network adapted to the building geometry.

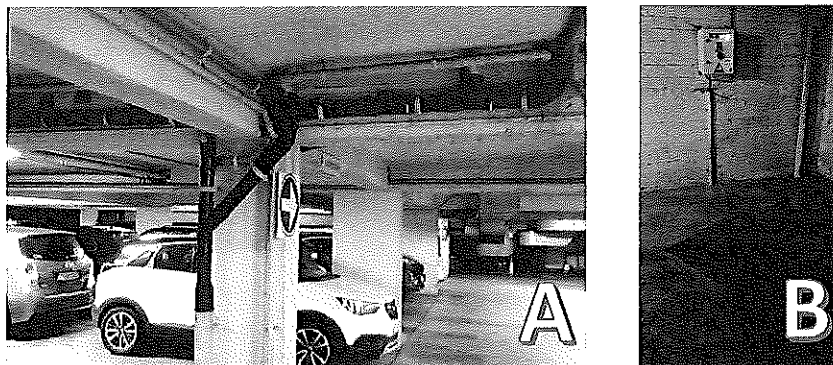
ACP headquarters. At different locations of the basement, we have seen repairs or modifications with HDPE pipes integrated into the existing drainage system. The sewage network of the building is a unitary system. In other words, it means that wastewater and rainwater are joined drained together, through a visit chamber located on the property line, in the same collector before joining the public sewer.

Figure 10 : Sewage system – (A) HDPE (black) and PVC (white) pipes; (B) Location of the wastewater pump

Due to the obsolescence of sewage and rainwater networks, it is mandatory to replace all drainage pipes by new ones (in HDPE and/or PVC), with layout and dimensions adapted to the constraints of the refurbished building.

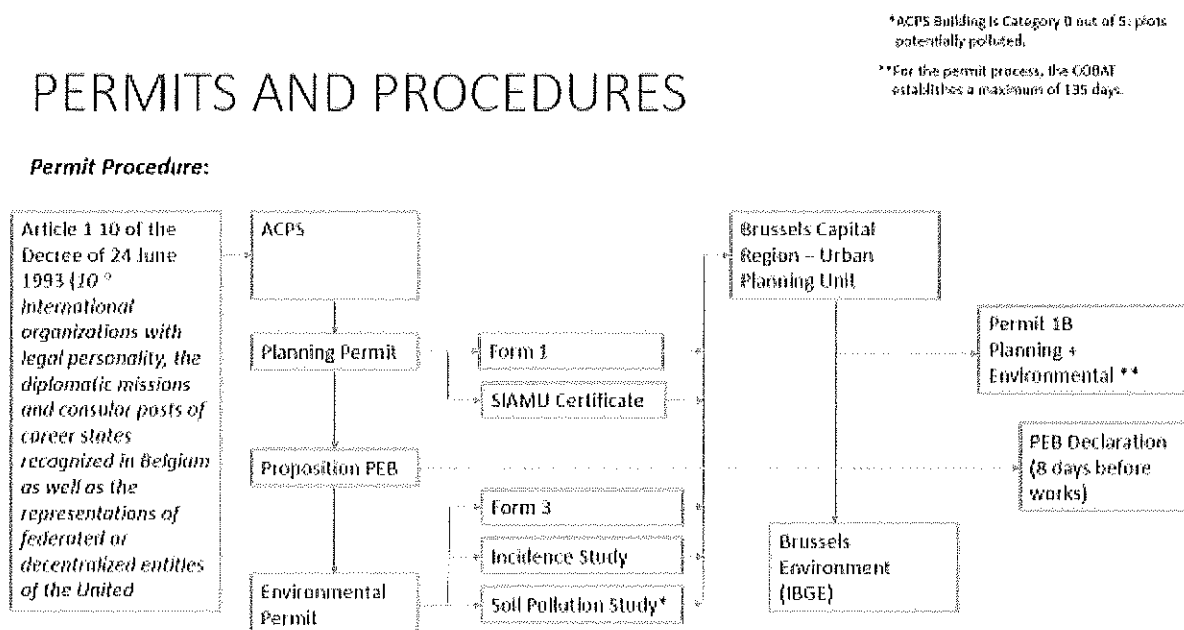
The permit process is summarized in the following illustration:

Figure 14 : Summary diagram of permits process and procedures (source: Annex G -Abridged Study Permit and Procedures)
